**EXPERIMENTAL MAINTENANCE PAINTING
OF I-65 IN LOUISVILLE
FEDERAL AID RESEARCH TASK NO. 108**

Research Report
KTC-02-25/FR108-01-1F

October 2002

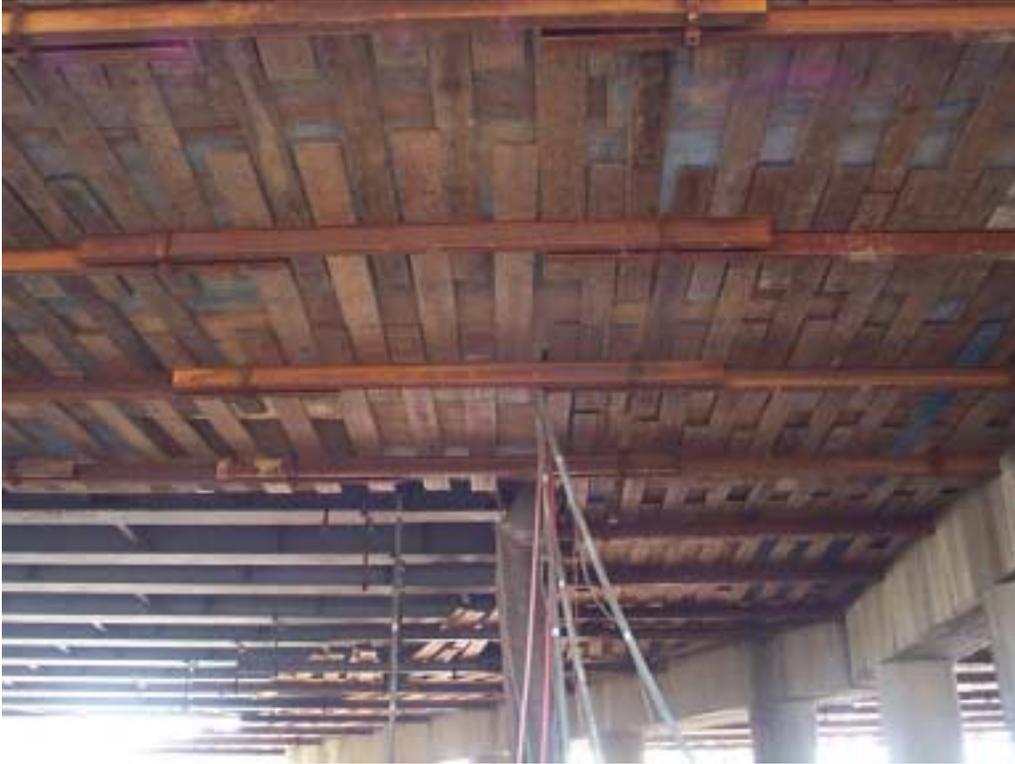
Figure 3. View of containment structure on the Main Street Bridge during maintenance painting operation.

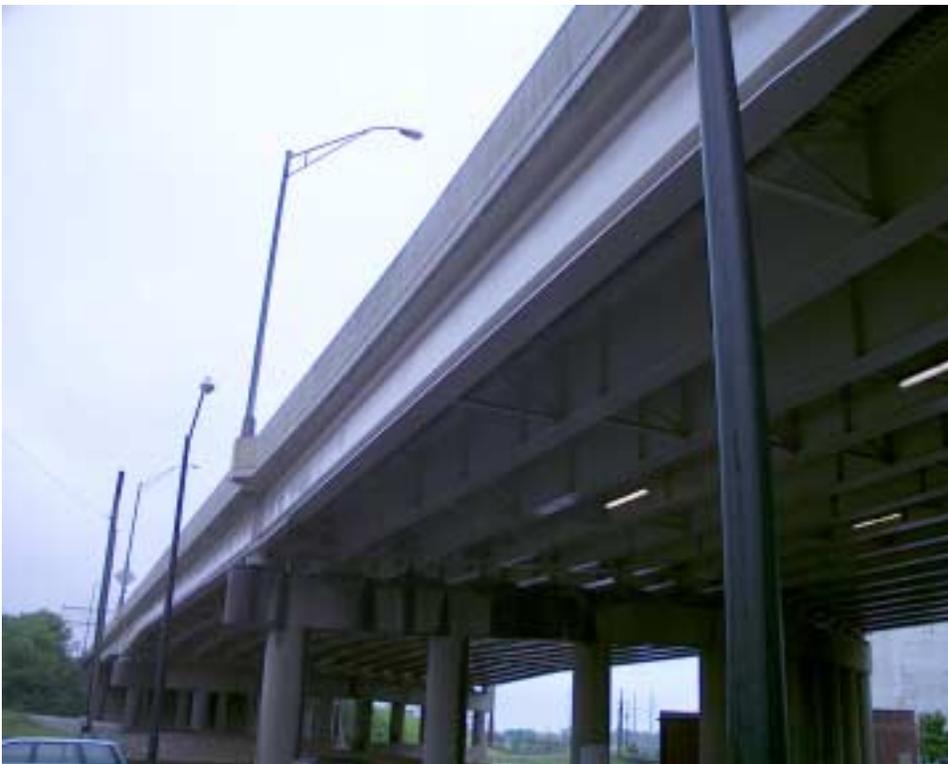
Figure 4. Finished view of the Main Street Bridge.

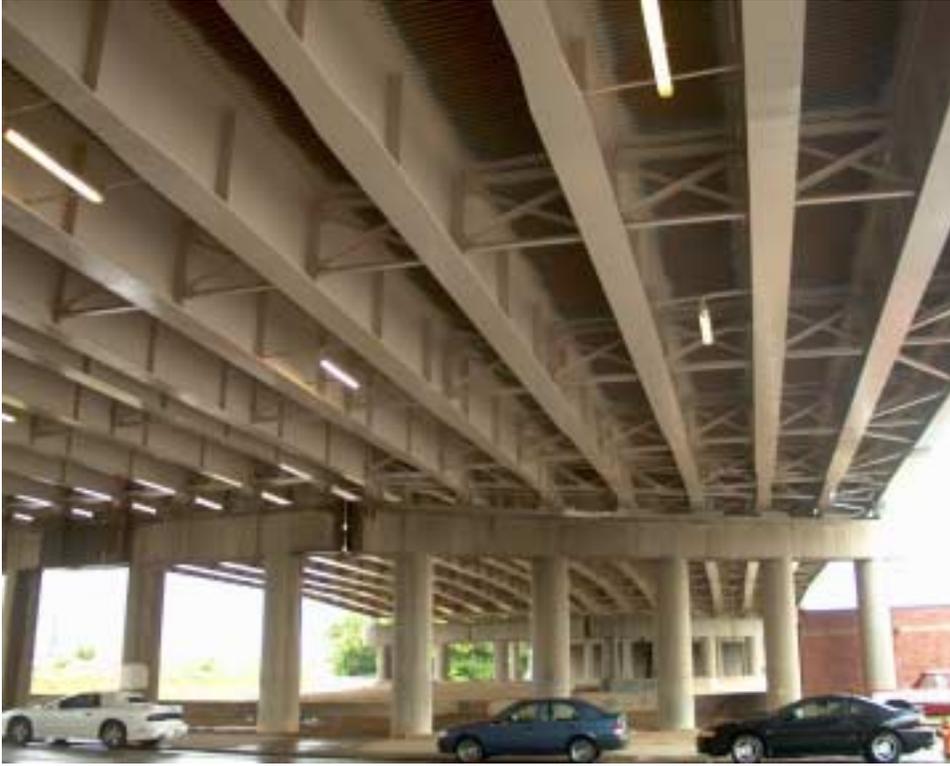
Figure 5. Completed view of the girders on the Main Street Bridge.

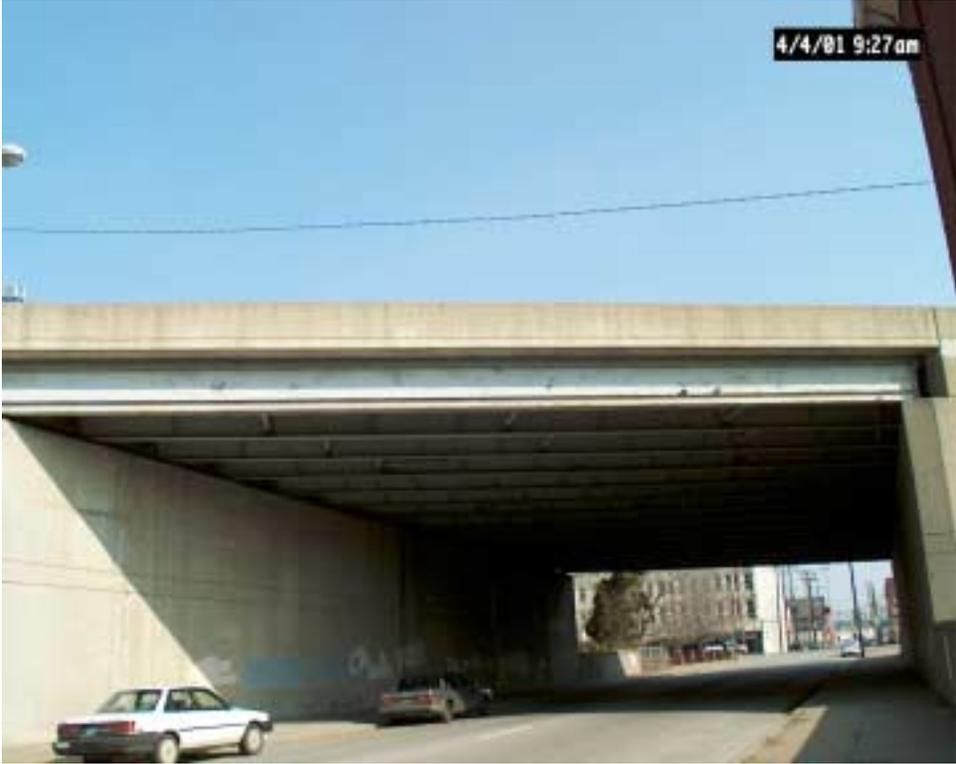
Figure 10. Overall view of the Jackson Street Bridge prior to maintenance painting.

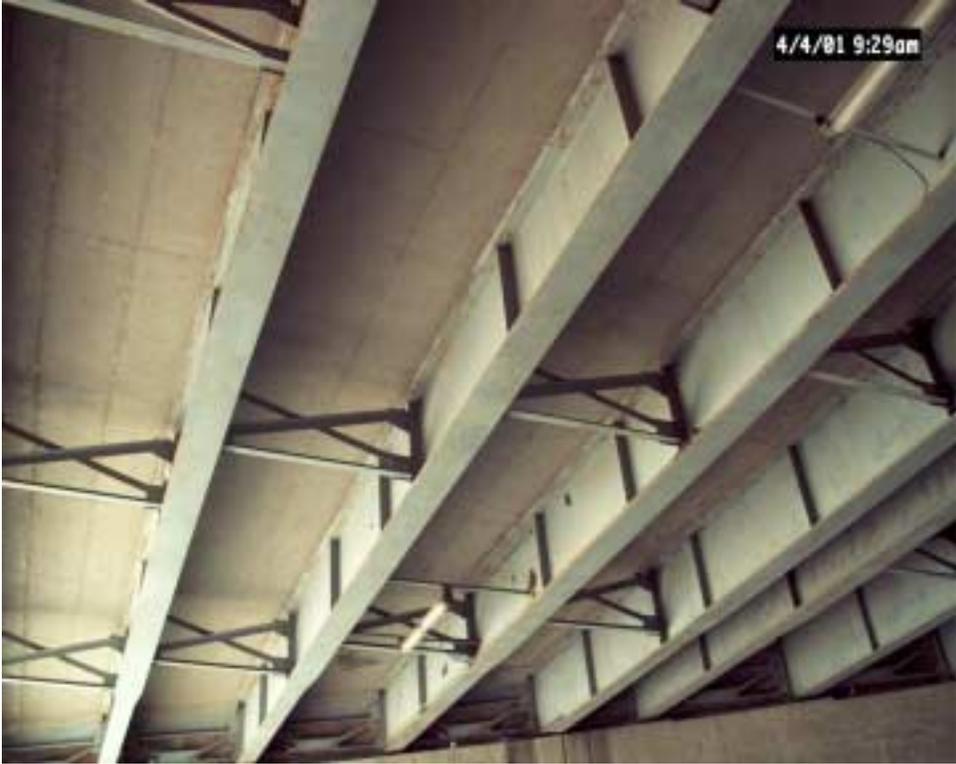
Figure 11. View of the girders on the Jackson Street Bridge before painting.

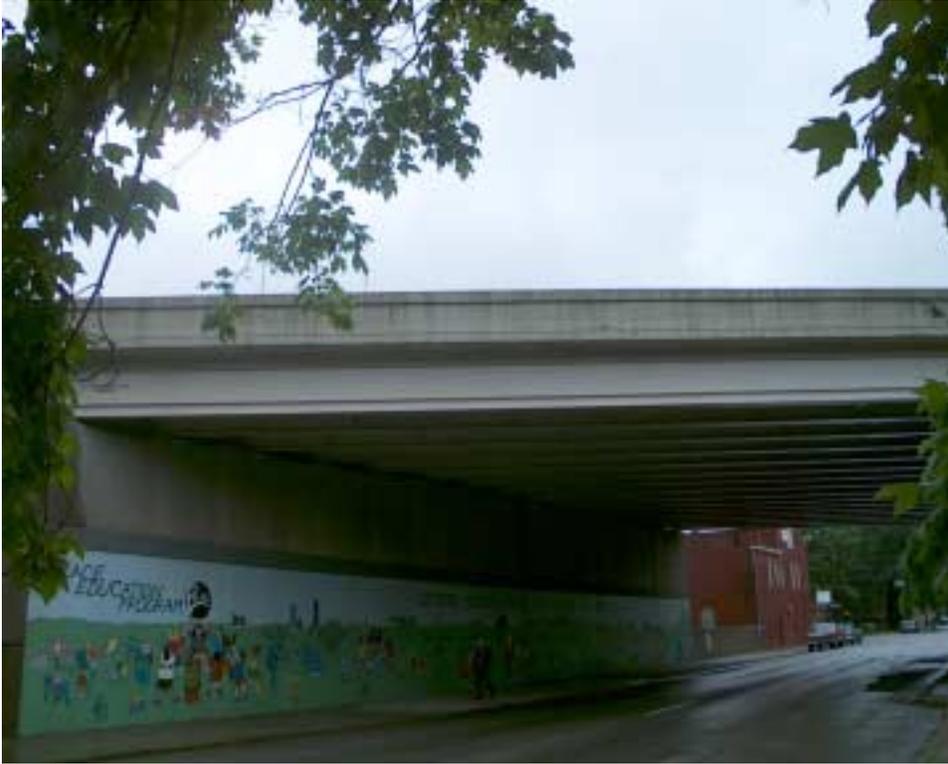
The final inspection of the bridge on September 12, 2001 revealed that all work was completed properly within general conformance of the **Standard Specifications and Special Notes** applicable to this project with some minor exceptions. The contractor was to repair holidays and missed spots in the finish coat. Also, some random cracking in the intermediate coat was found, mostly along the diaphragms and steel near the abutments. Repair of these areas was done by sanding or grinding the cracked coating and reapplication of intermediate and finish coats. The work area required cleaning of debris and waste removal before the project could be approved. Personnel from KYTC Central Office Division of Construction and District 5, the Kentucky Transportation Center, and the contractor were present for that final inspection.

Figure 12. Overall view of the Jackson Street Bridge after painting.

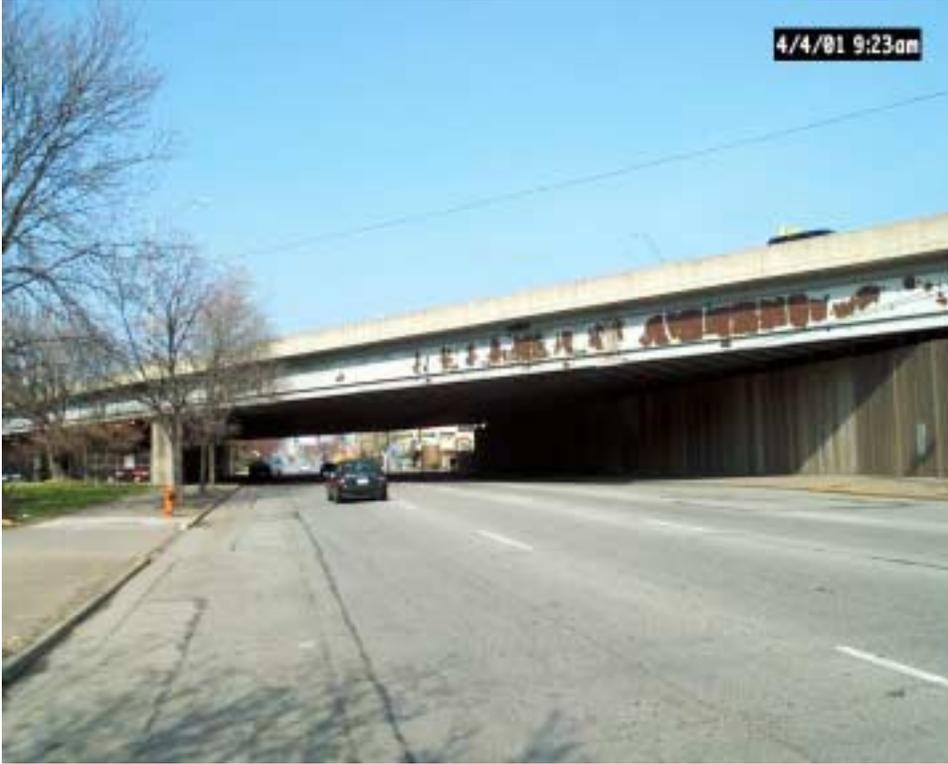
Figure 14. View of bridge at Preston and Jefferson Streets prior to painting.

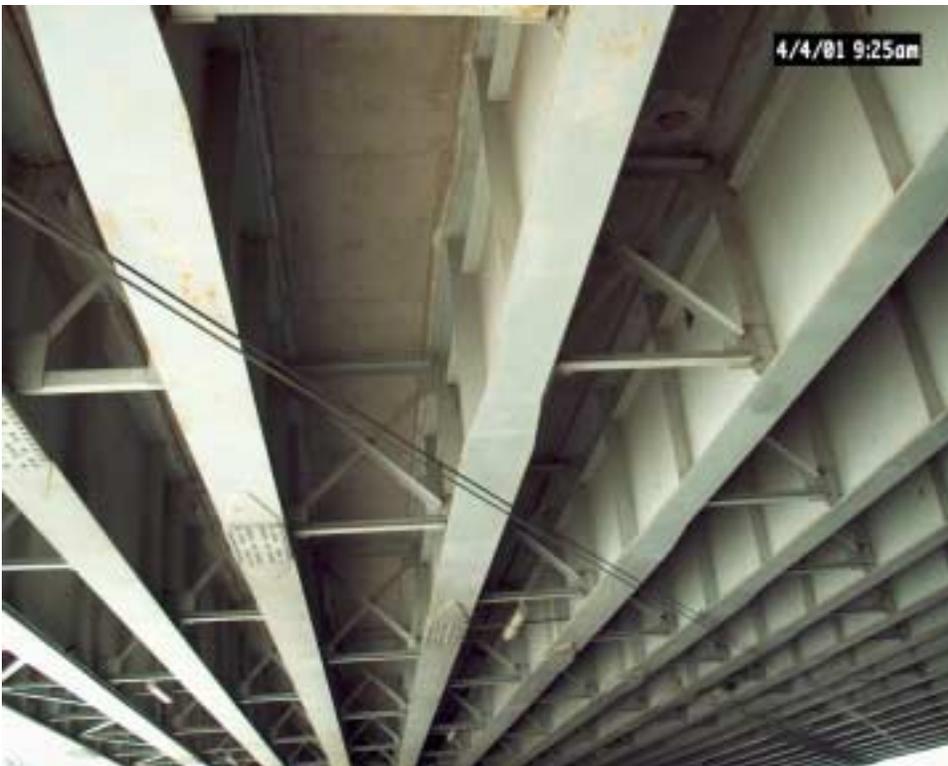
Figure 15. Girders of bridge at Preston and Jefferson Streets before painting.

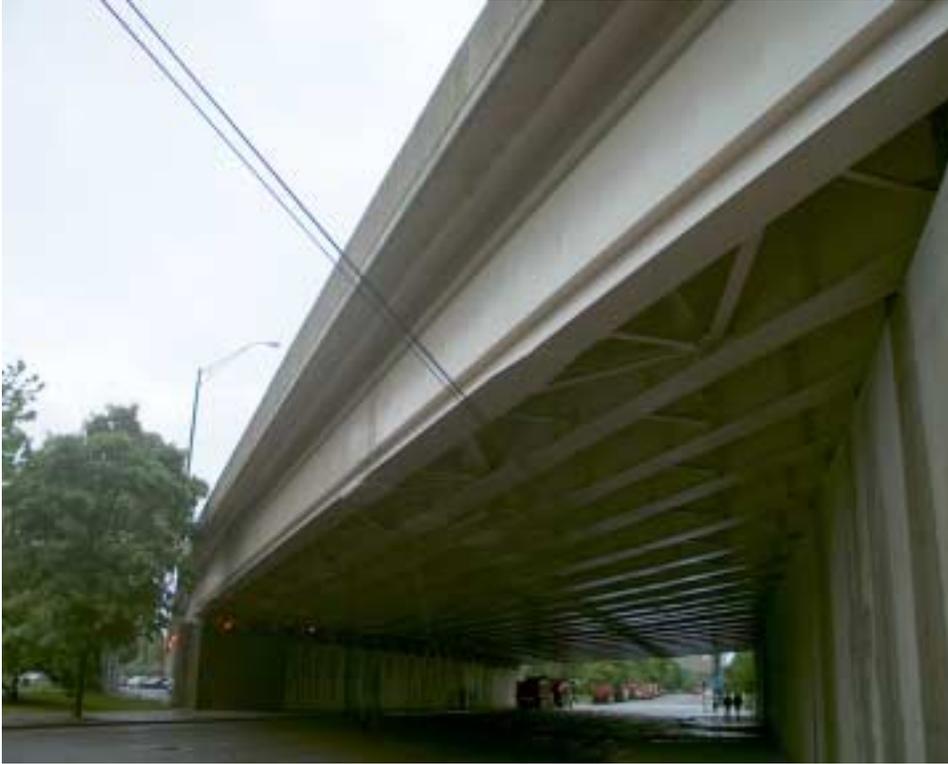
A final inspection was performed on August 17, 2001 for this bridge. Personnel from KYTC Central Office Division of Construction and District 5, the Kentucky Transportation Center, and the contractor were present for that final inspection. The inspection revealed that several control areas needed touch up work for fixing holidays especially around the bolts, missed spots, cracking and application flaws. The work area was to be cleaned and all debris and waste removed from site. The final inspection report revealed that all work was completed properly within general conformance of the Standard Specifications and Special Notes applicable to this project with the above noted exceptions.

Figure 16. View of bridge at Preston and Jefferson Streets after painting.

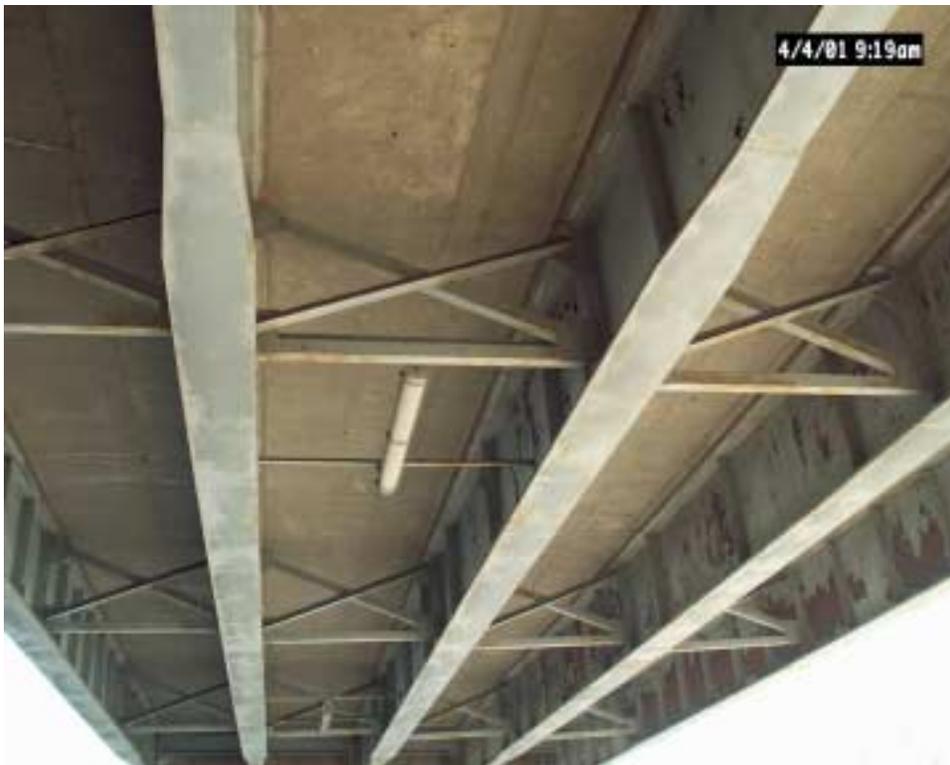
Figure 19. View of girders at the approach ramp at Liberty Street prior to painting.

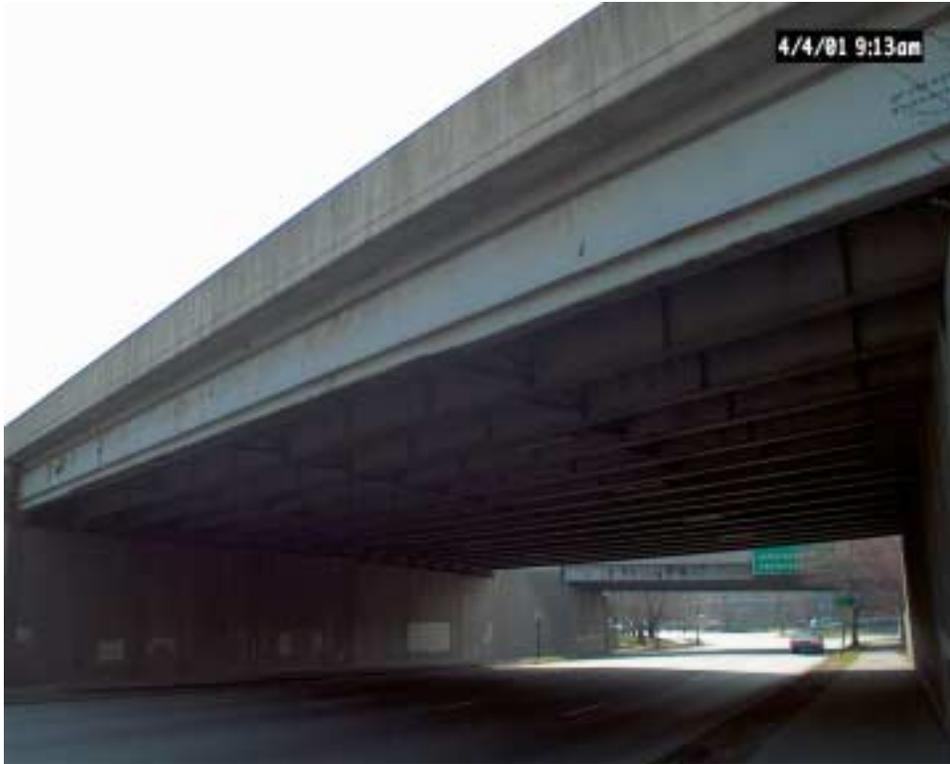
Figure 22. View of bridge at Liberty Street prior to painting.

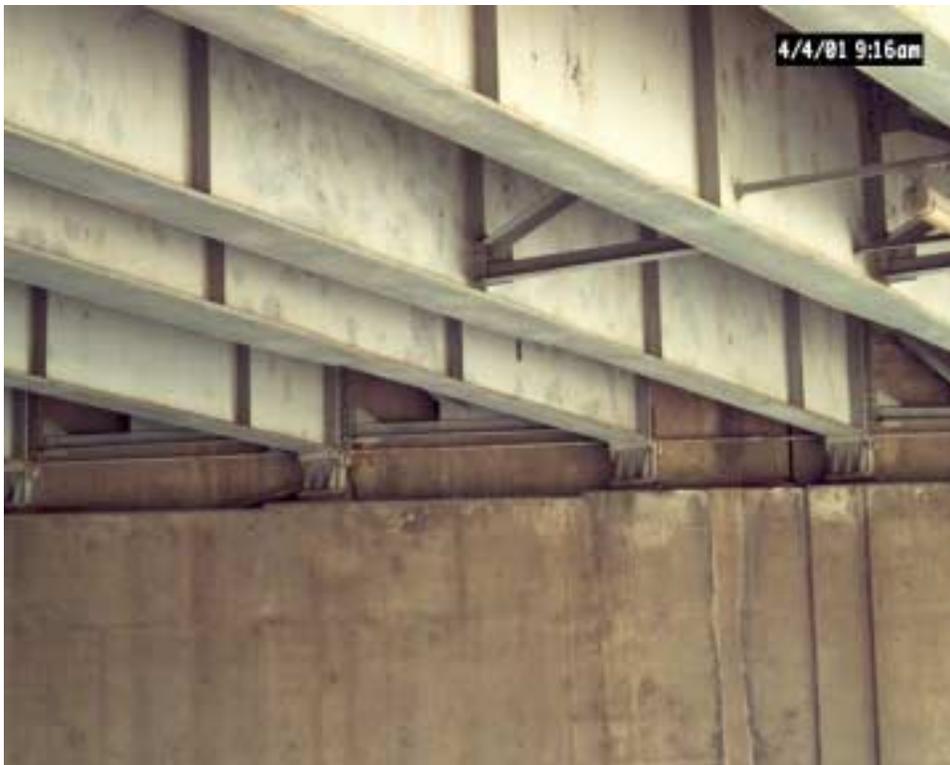
Figure 23. Girders on bridge at Liberty Street before painting.

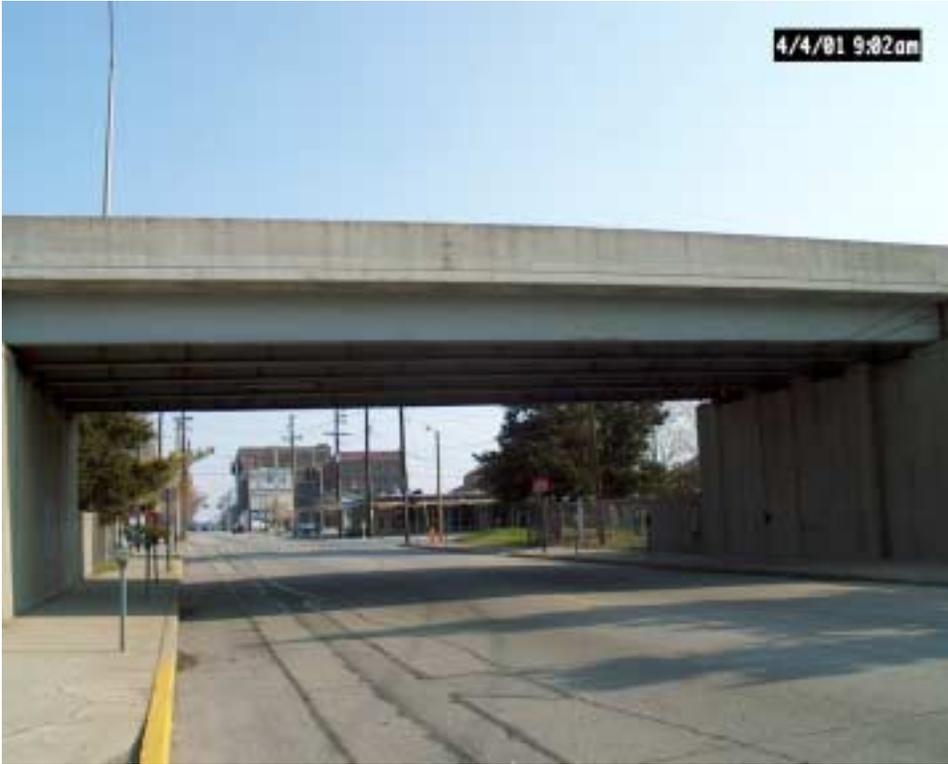
Figure 26. Overall view of Floyd Street Bridge before painting.

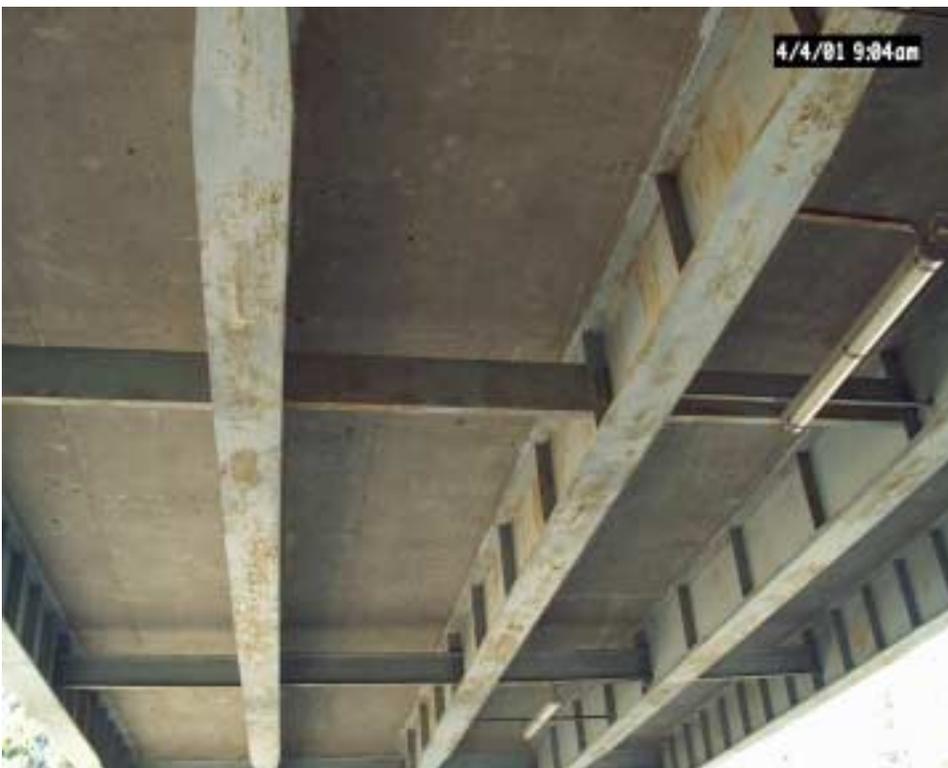
Figure 27. Girders on Floyd Street Bridge before painting.

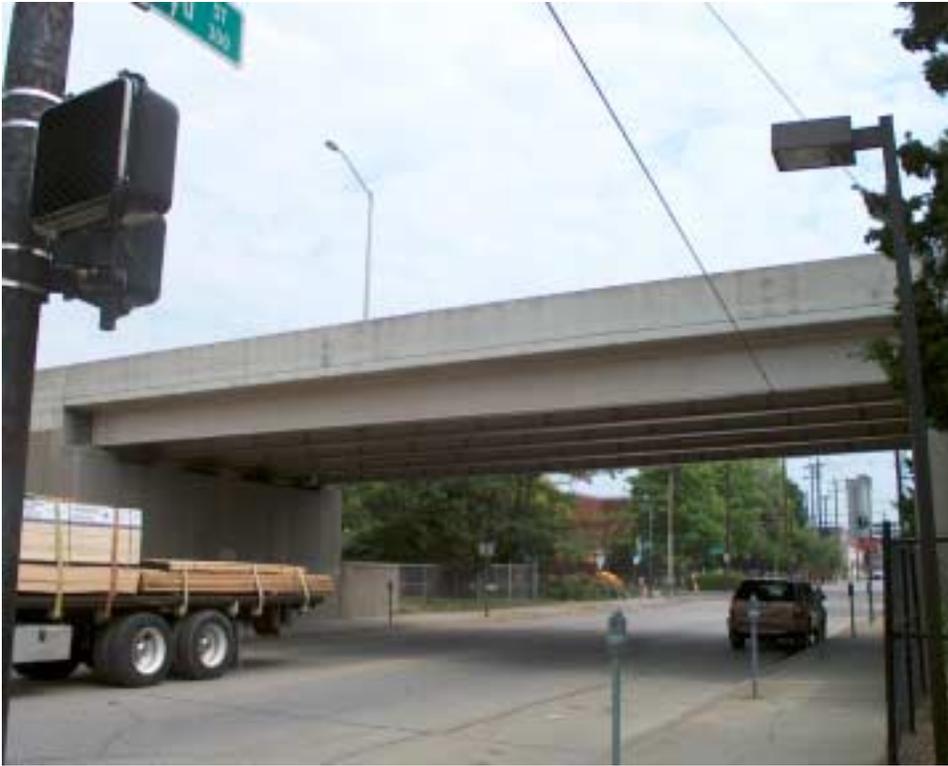
The final inspection of the bridge on October 15, 2001 revealed that all work was completed properly within general conformance of the **Standard Specifications and Special Notes** of this project with the following exceptions. The bridge had numerous holidays and light spots in the finish coating, which required sanding to roughen up the areas and reapplication of finish coat to proper DFT. The work area also needed to be cleaned and all debris and waste removed. Personnel from KYTC Central Office Division of Construction and District 5, the Kentucky Transportation Center, and the contractor were present for that final inspection.

Figure 28. Bridge at Floyd Street after painting.

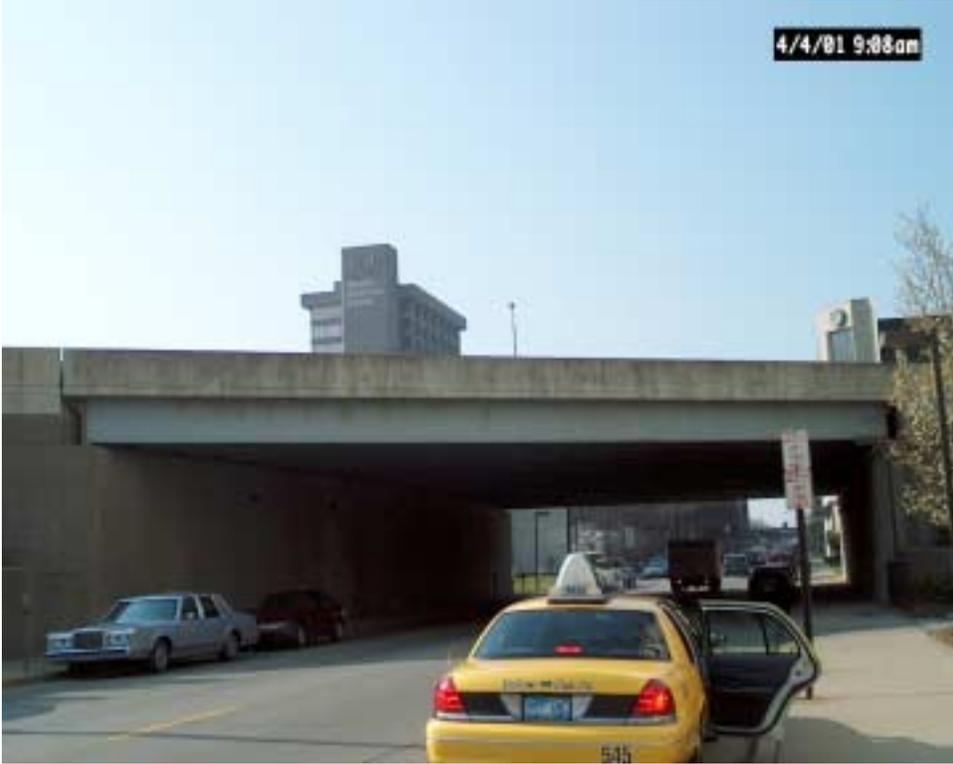
Figure 30. Bridge at Floyd Street, South of Liberty before painting.

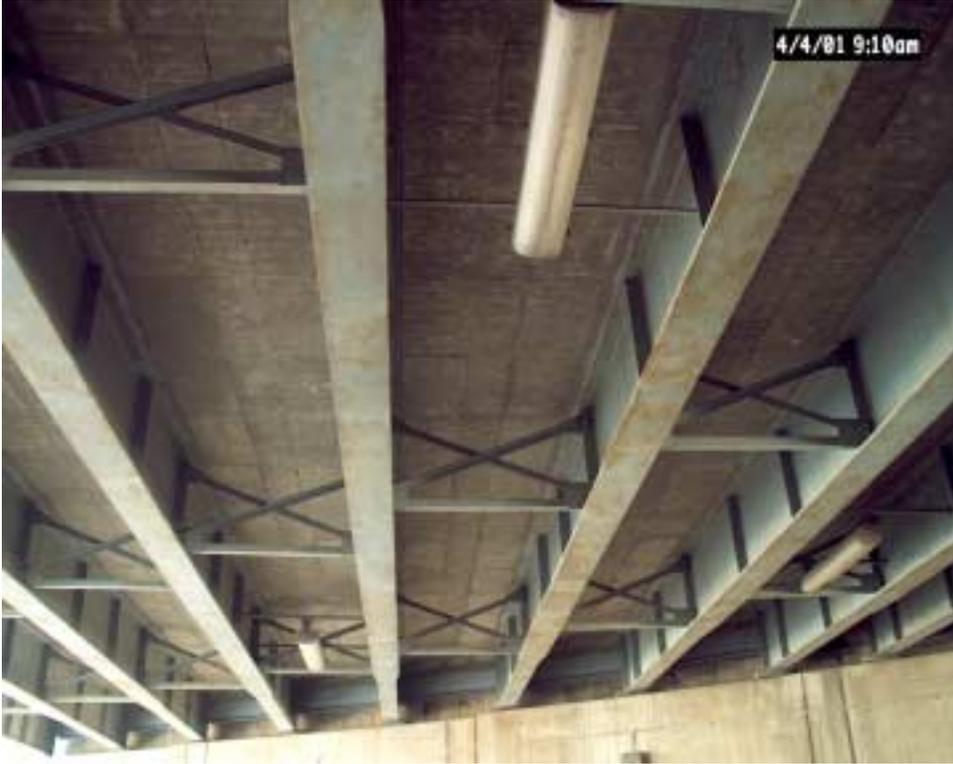
Figure 31. Girders at Floyd Street, South of Liberty before painting.

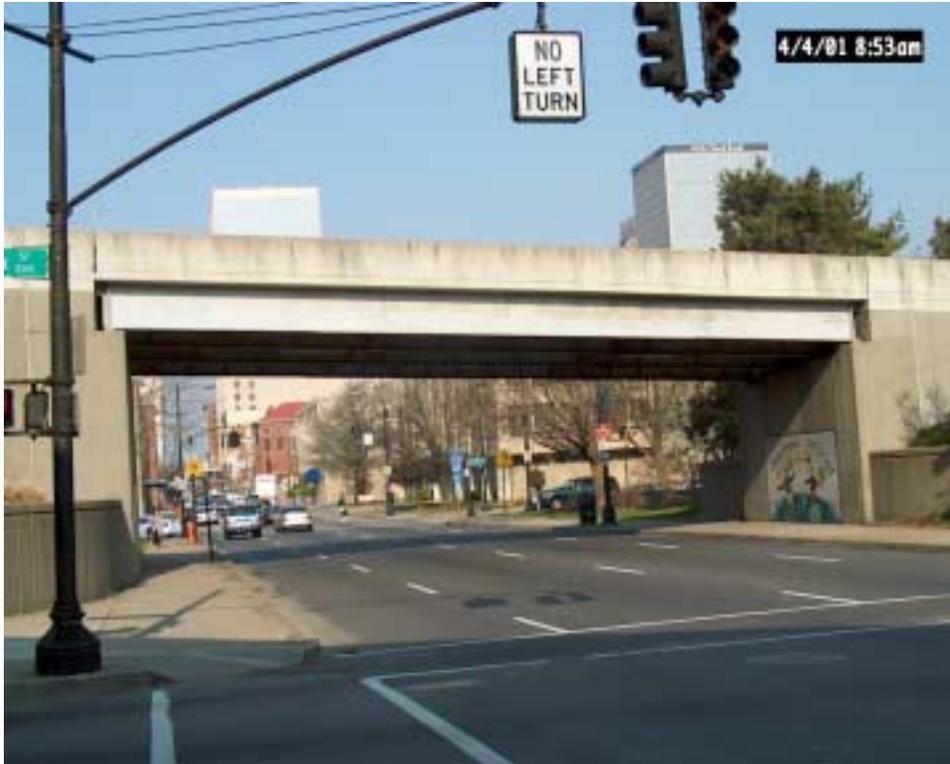
Figure 32. View of Muhammad Ali, West of Brook before painting.

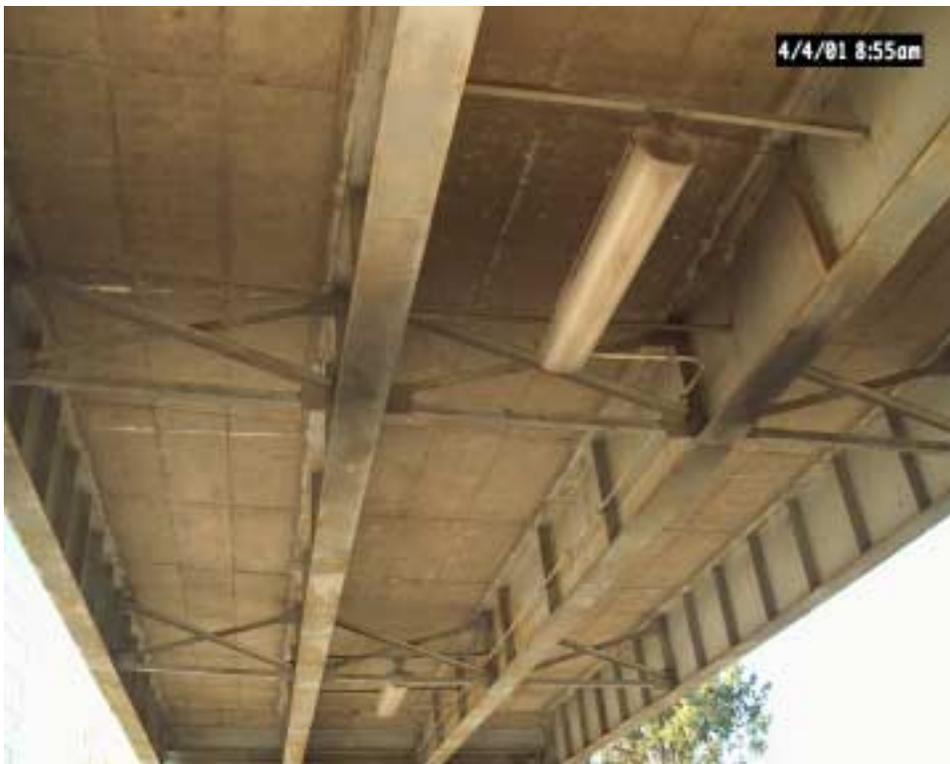
Figure 33. Girders at Muhammad Ali, West of Brook before painting.

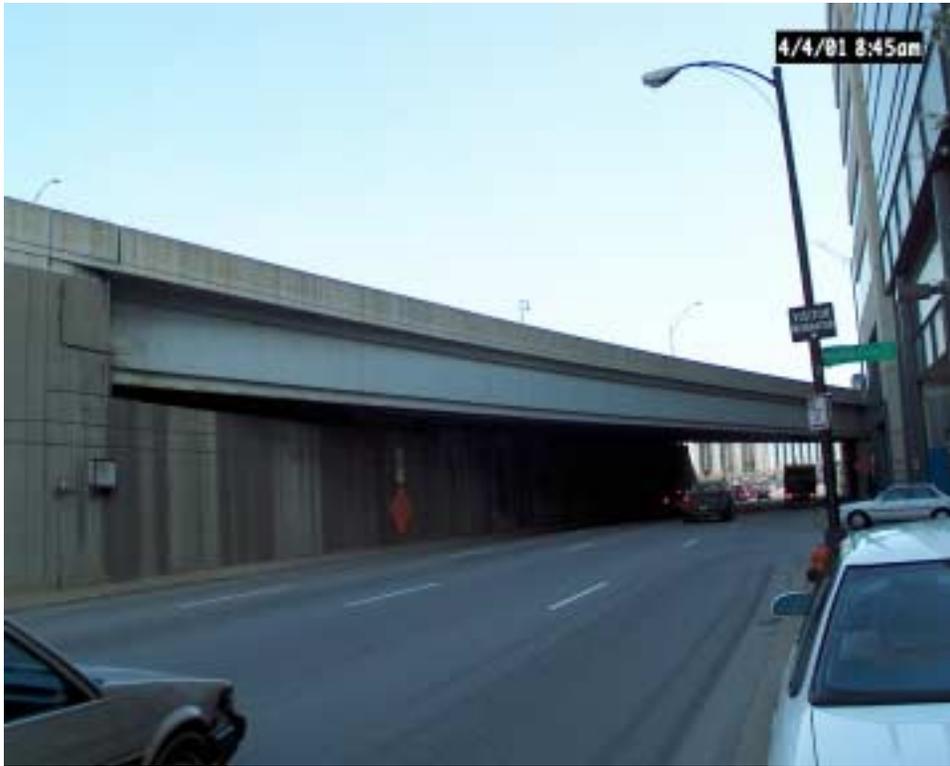
Figure 35. View of bridge at Muhammad Ali, East of Brook before painting.

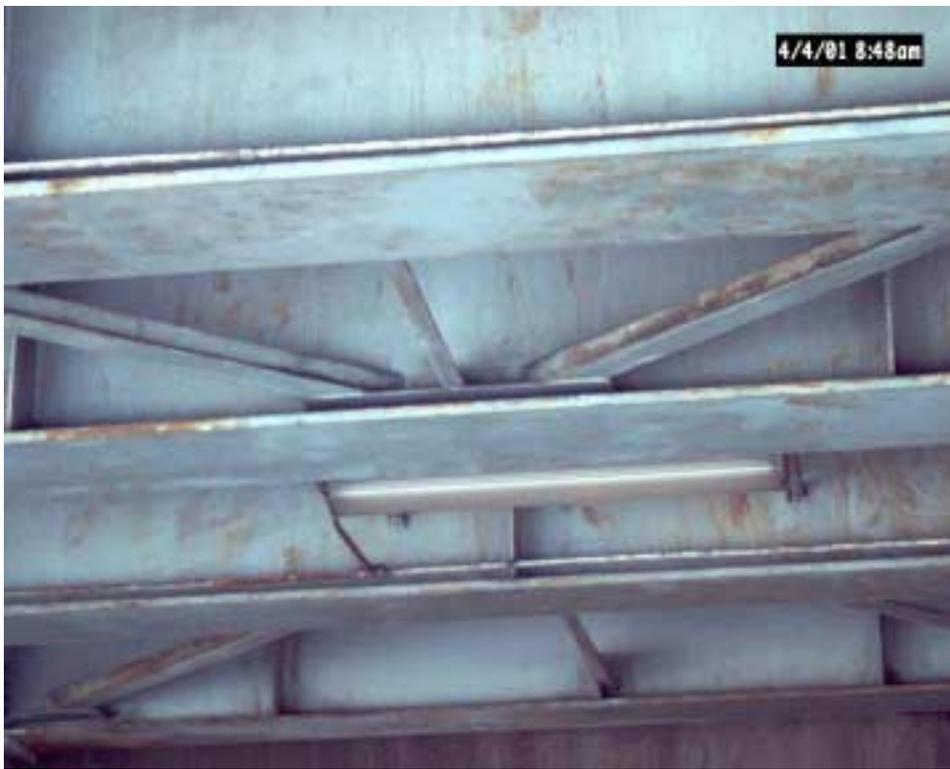
Figure 36. View of girders on bridge at Muhammad Ali, East of Brook before painting.

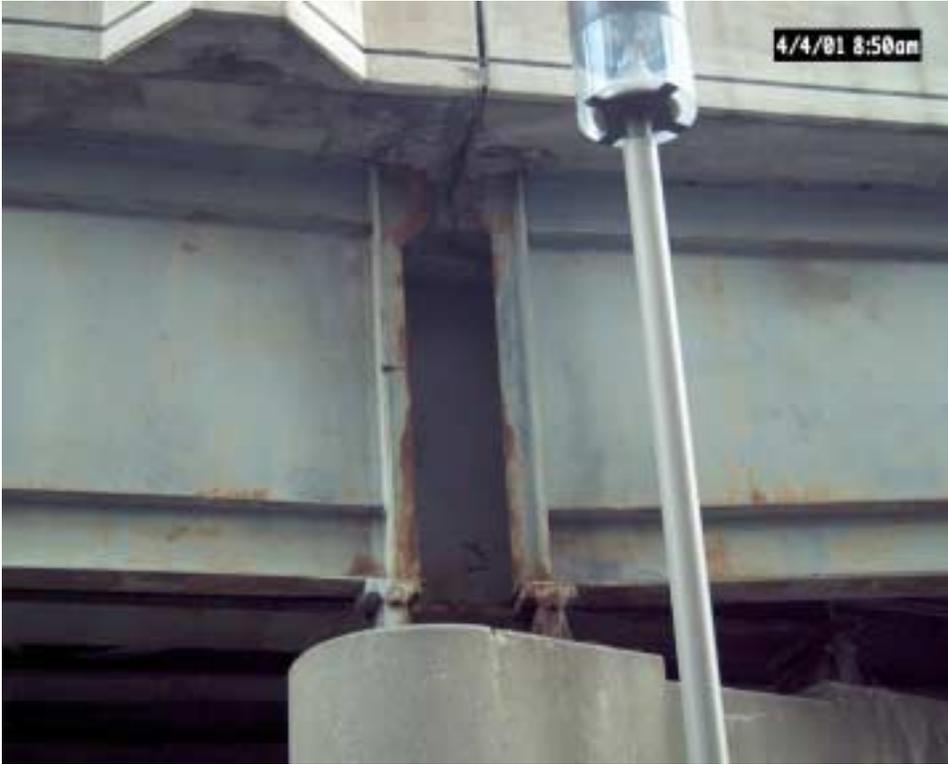
Figure 37. View of joint at Muhammad Ali, East of Brook before painting.

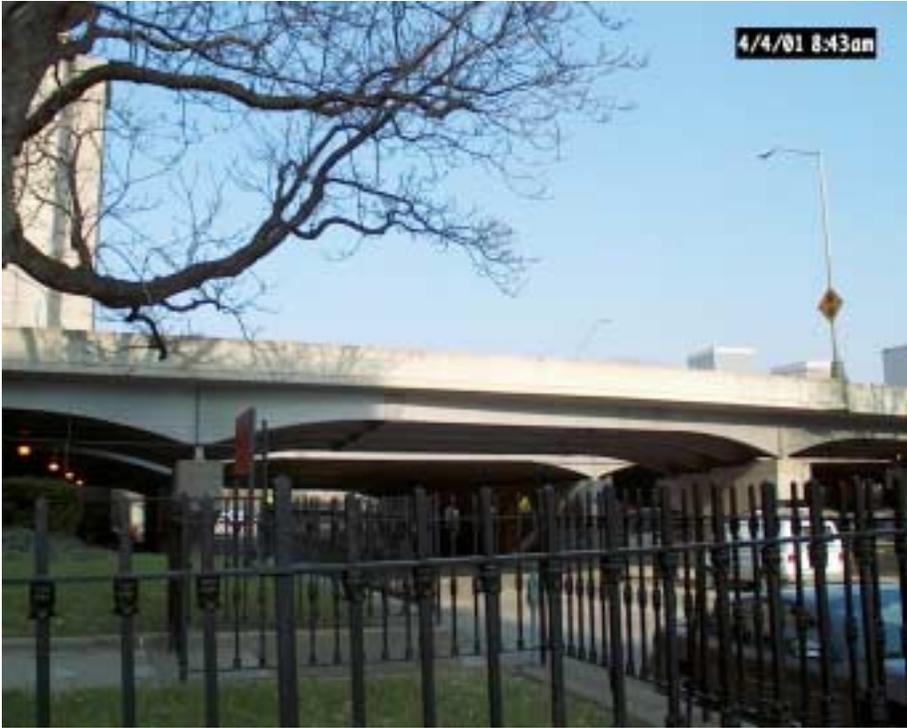
Figure 40. View of bridge at Jacobs-Broadway-Gray, between 1st and Brook before painting.

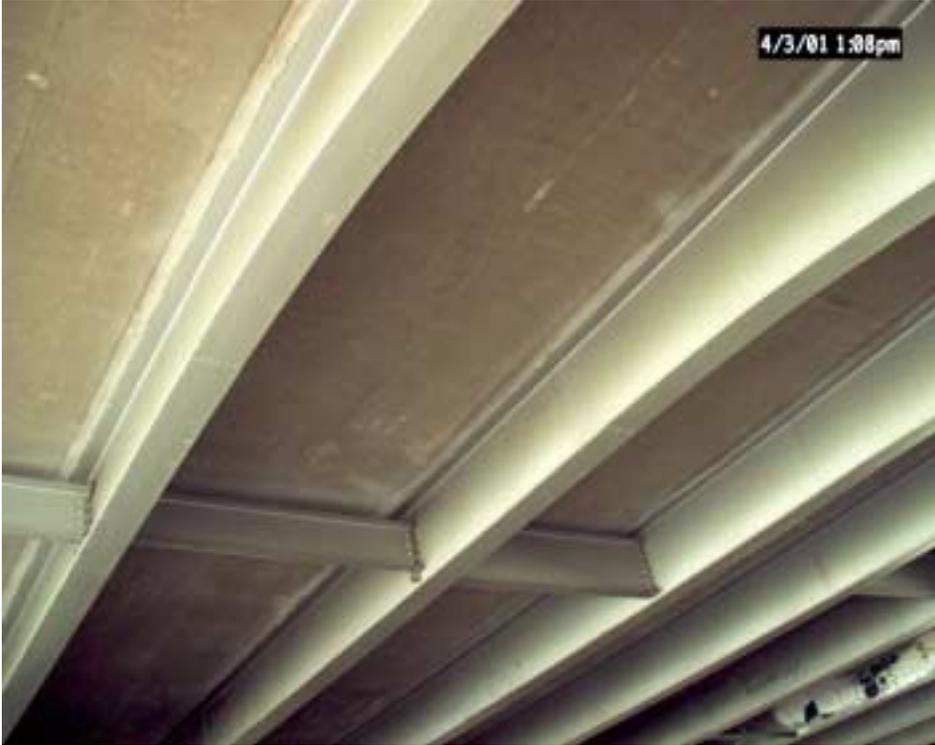
Figure 41. Girders on bridge at Jacobs-Broadway-Gray, between 1st and Brook before painting.

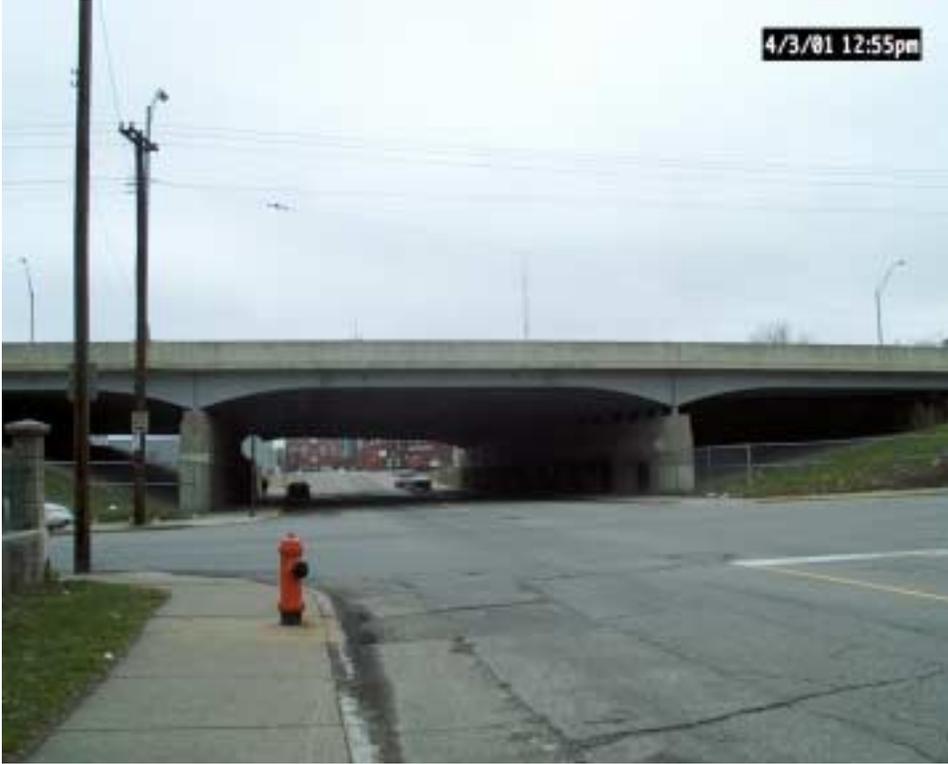
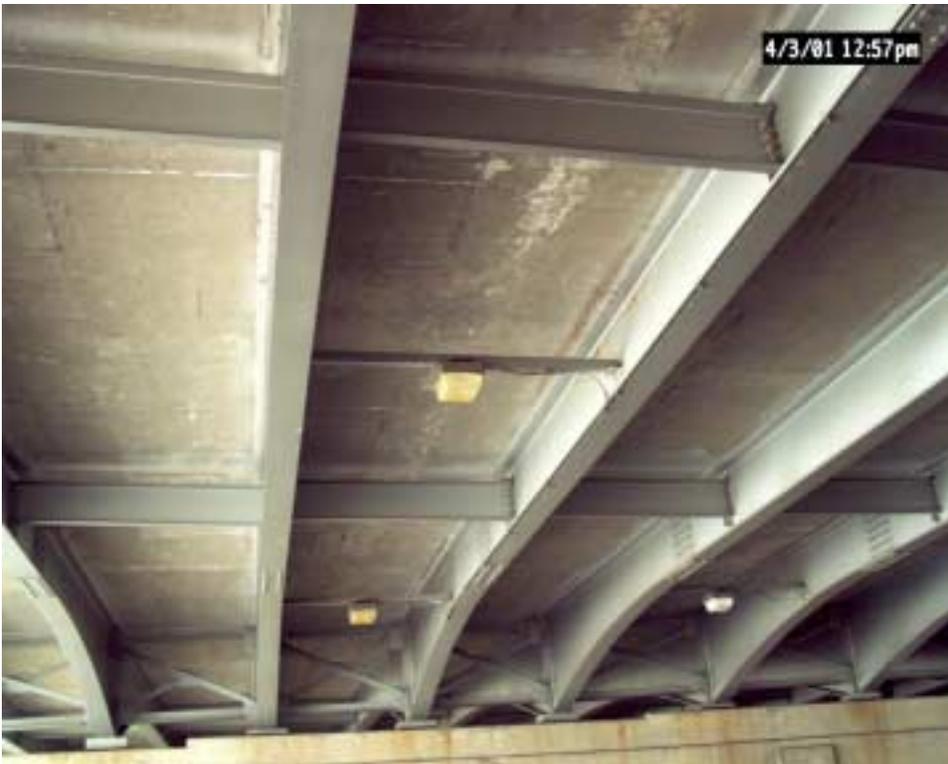
Figure 43. Bridge at College Street, between 1st and Brook before painting.

Figure 44. Girders on bridge at College Street, between 1st and Brook before painting.

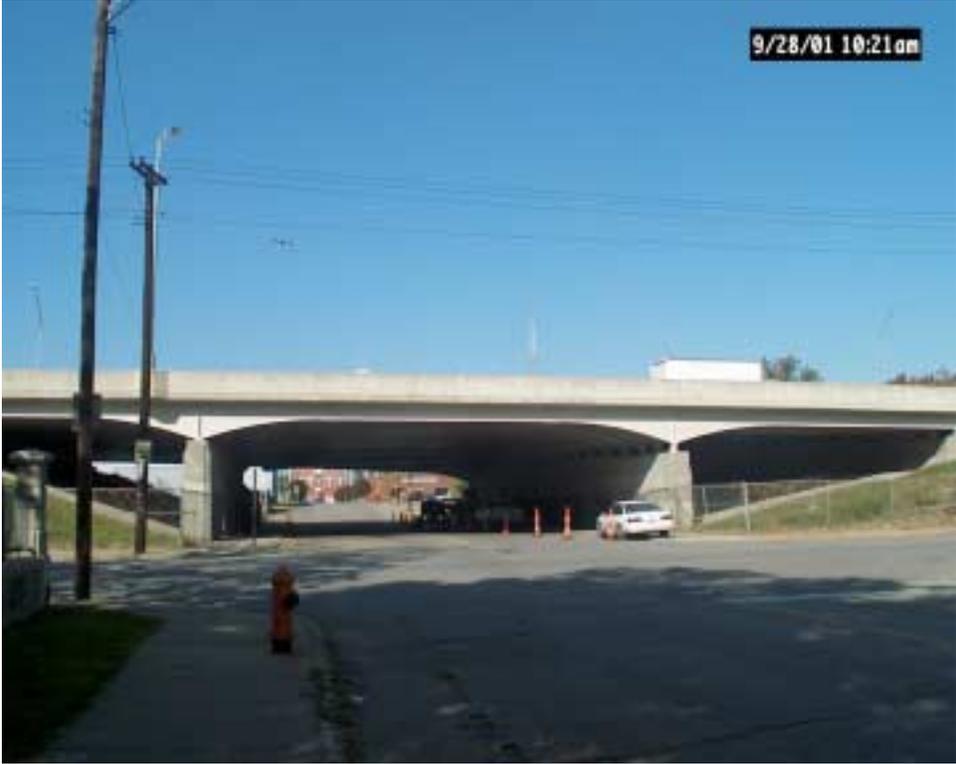
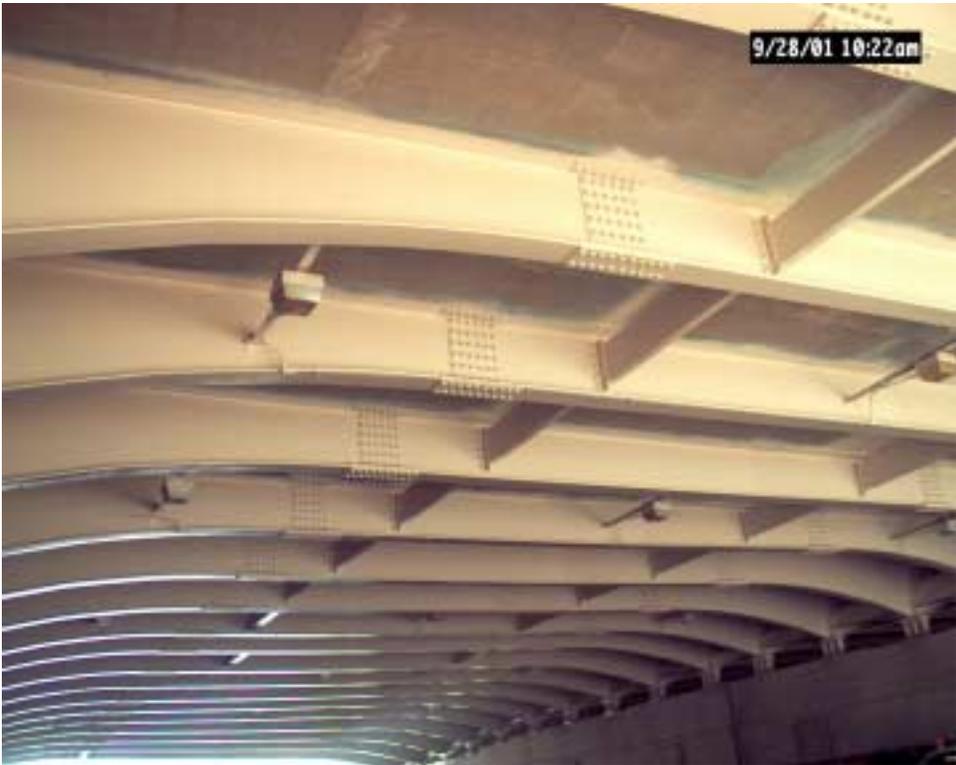
A final inspection was performed on September 28, 2001. Cracks in the intermediate coating on nearly all the rockers and feet at the abutment were to be ground down and repaired by applying additional intermediate coat where needed and reapplying finish coat. The work area was to be cleaned and all debris and waste removed from site. Personnel from KYTC Central Office Division of Construction and District 5, the Kentucky Transportation Center, and the contractor were present for that final inspection.

Figure 45. View of bridge at College Street, between 1st and Brook after painting.

Figure 46. Girders on the bridge at College Street, between 1st and Brook after painting.

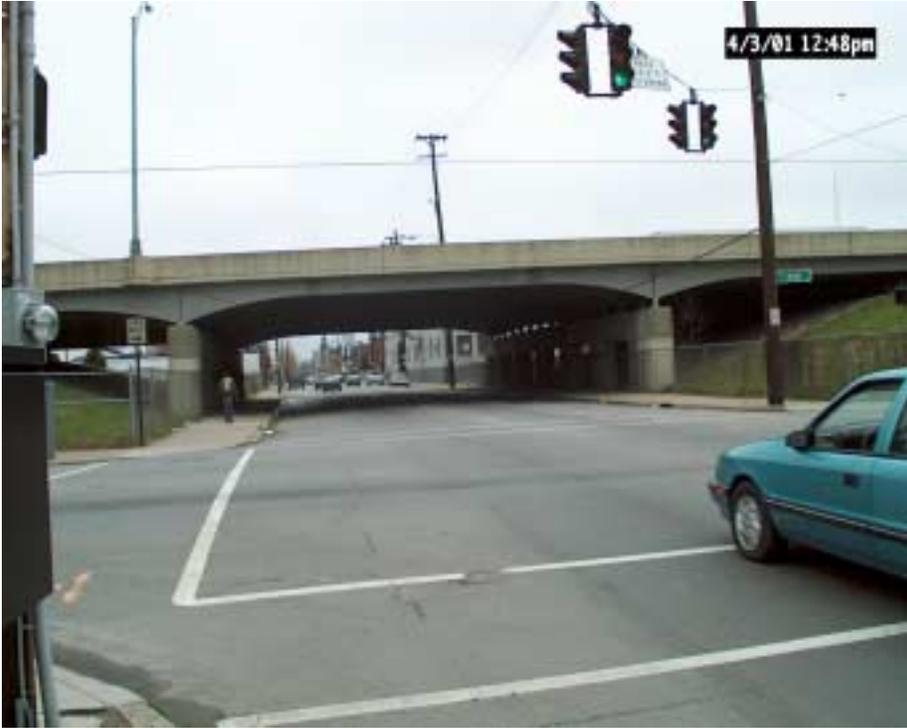
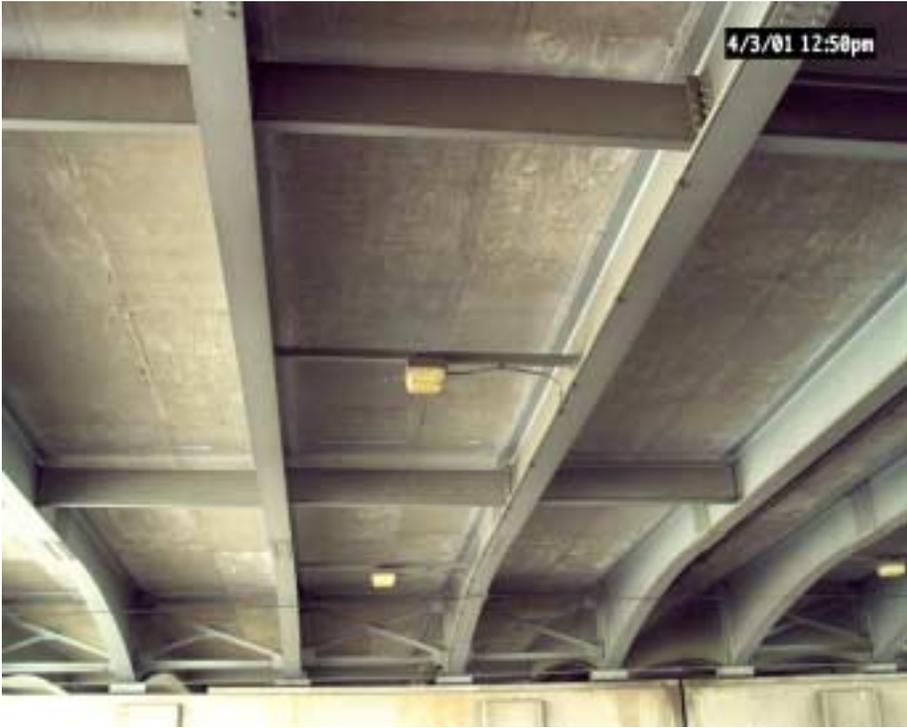
Figure 47. Bridge at Breckinridge Street, between 1st and Brook before painting.

Figure 48. Girders on bridge at Breckinridge Street, between 1st and Brook before painting.
